# Residential Inspection Report

## To NZS4306:2005

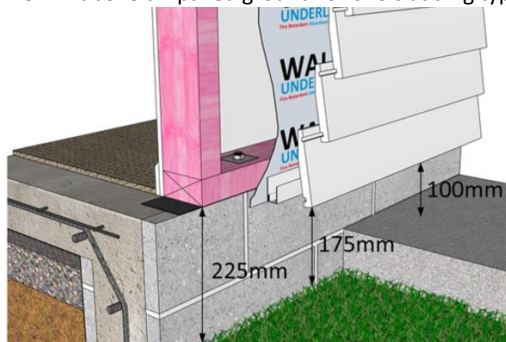
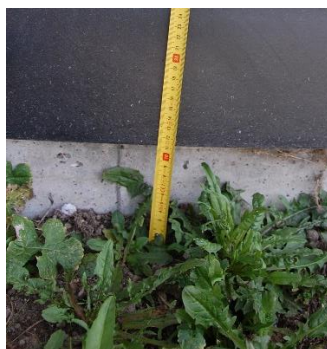
- Insufficient ground clearance of weatherboard cladding – 100mm to unpaved ground
- Gully traps have insufficient ground clearance – 35mm to unpaved ground

Cladding is required to have specific ground clearances to reduce potential damage from moisture ingress and capillary action, where water gets sucked up between the cladding and the framing causing internal damage. Not adhering to ground clearances can create a weathertightness risk.

For cladding other than masonry, the bottom of cladding to ground clearances to be 100mm above paved ground or 175mm above un-paved ground for this cladding type.

These have been included together as they are both caused by the same issue of soil being added too high along this wall. Either the soil could be taken down a little, or it would be worth considering adding either a concrete or concrete paver mowing strip along where the weatherboard cladding and gully trap are on the south elevation, and around the gully trap on the east elevation – this would mean you then only need a 100mm clearance for the cladding, and 25mm for gully traps, which they both currently are. This would also reduce the growth of grass/vegetation up under the cladding or over the gully traps, and makes for easier mowing.

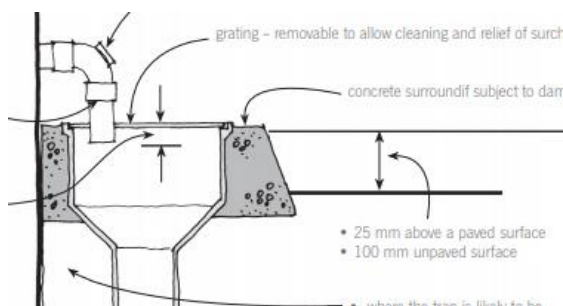
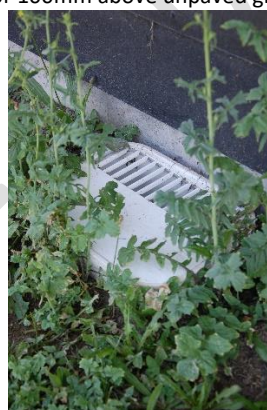
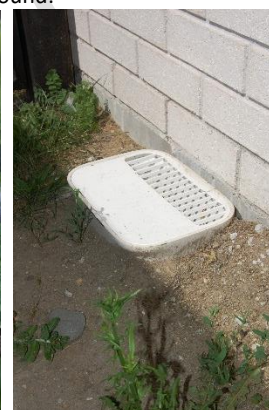
Gully traps are required to be 25mm above paved areas or 100mm above unpaved ground:

This is to stop surface water and debris from getting into the council grey-water system, to reduce the possibility of flood waters backing up into the house, and to stop debris from blocking drains which will also cause pipe waste to back up into the house.
